**RUSTIC HILLS LAKE DAM
JEFFERSON COUNTY, MISSOURI
MO 30467**

PHASE 1 INSPECTION REPORT NATIONAL DAM SAFETY PROGRAM

Rustic Hills Lake Dam ~~Jefferson County, Missouri~~
(MO#30467), Mississippi-Kaskaskia-St. Louis
Basin, Jefferson County, Missouri. Phase
I Inspection Report.

Name of Dam: Rustic Hills Lake Dam
State Located: Missouri
County Located: Jefferson
Stream: Tributary La Barque Creek
Date of Inspection: 5 July 1978

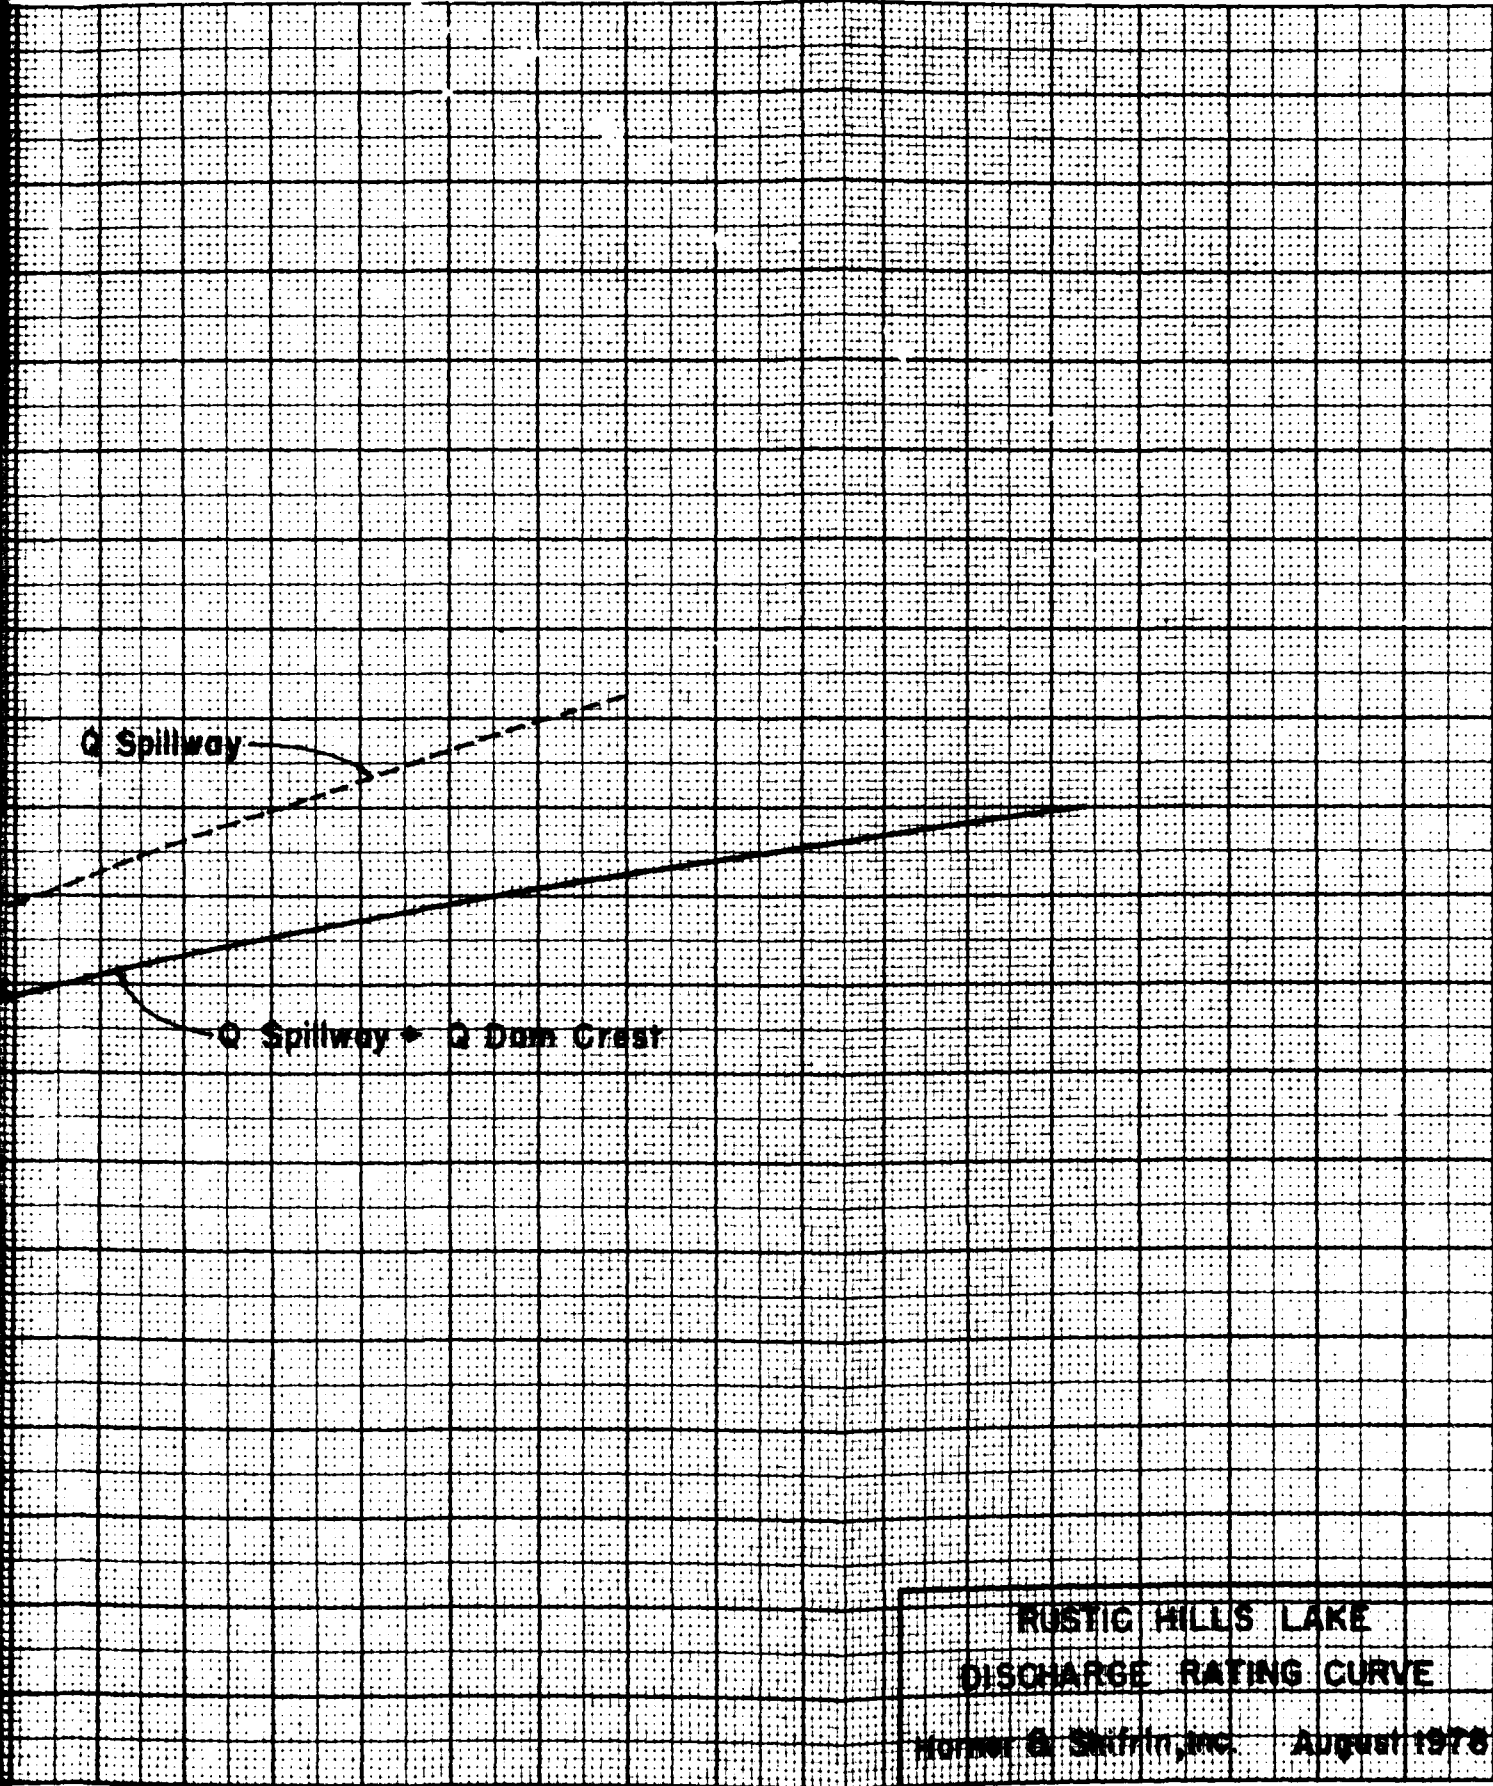
PLATE 3

RUSTIC HILLS LAKE
DISCHARGE RATING CURVE

3. The profile of the dam crest is irregular and flow over the dam crest cannot be determined by conventional weir formulas. Flow quantities overtopping the dam crest were computed as described in the preceding paragraph and corresponding flow over the dam and spillway for given elevations were added to obtain the combined outflow rating curve for the dam and spillway. This rating curve is shown on Plate 3. The inflow-outflow hydrographs for the PMF are shown on Plate 4.

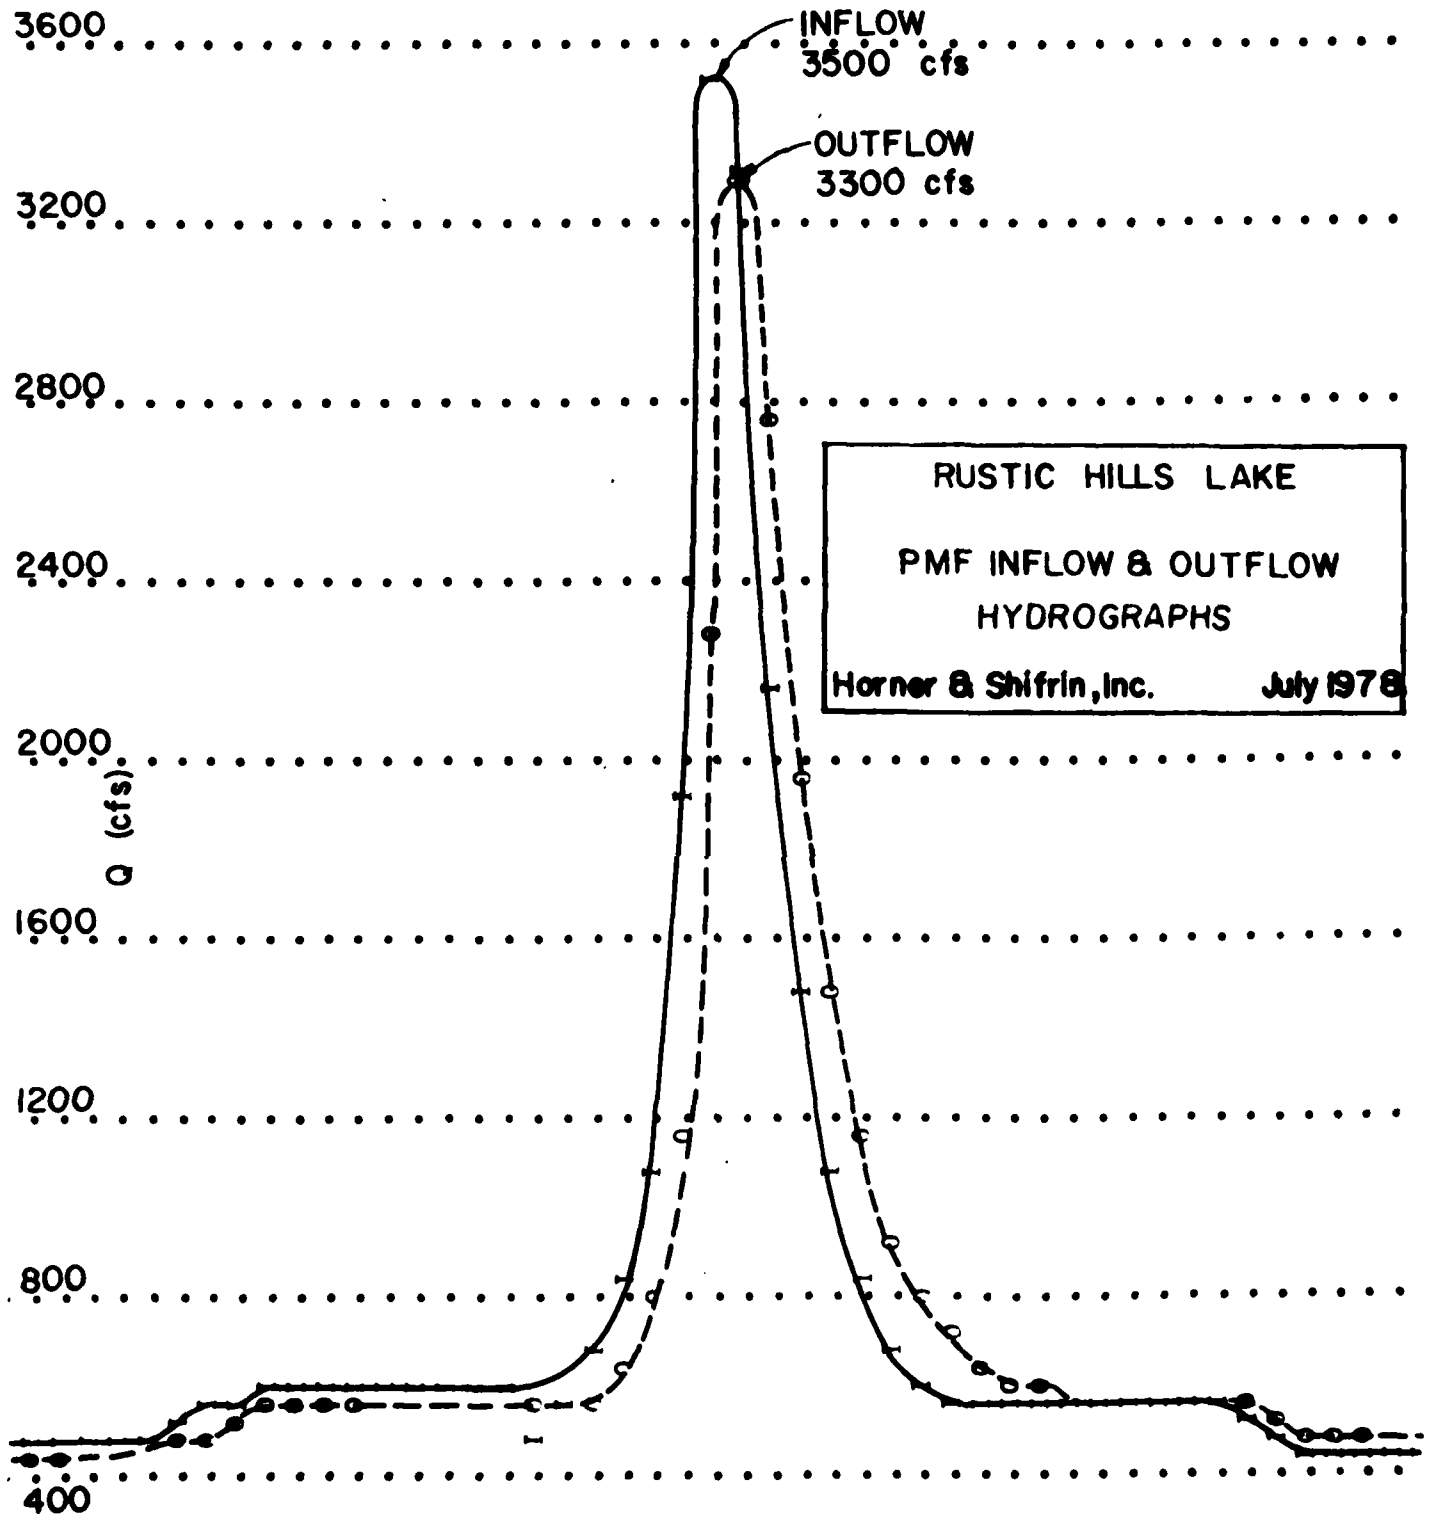
RUSTIC HILLS LAKE
 PMF INFLOW & OUTFLOW
 HYDROGRAPHS
 Horner & Shifrin, Inc. July 1978
